Manhole Inspection Summary

Manhole # S04UU1006MH

Insp Date: **7/27/06 7:07 AM**

Location Address: **4000 FORDLEIGH RD**

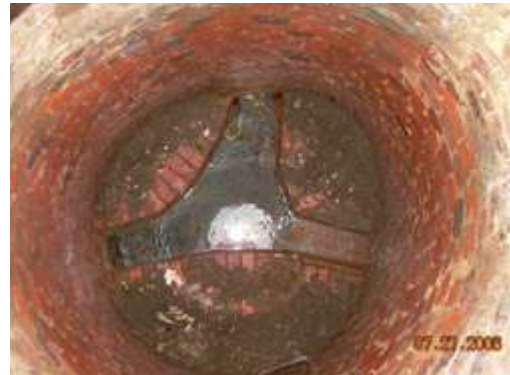
Top View

Adjustment and Barrel infiltration.
Evidence of surcharge - Bench debris.
Channel debris.

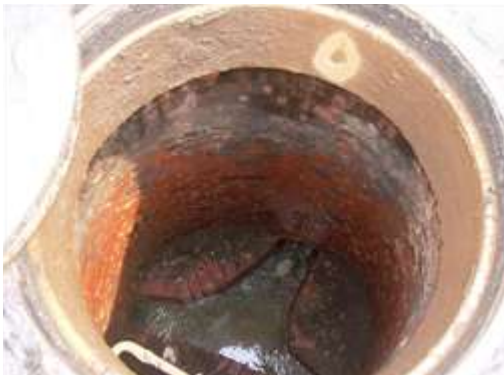
Defect

Frame leaks. Adjustment and Barrel infiltration.

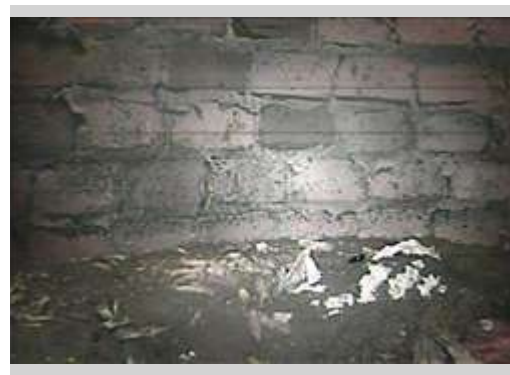
Defect

Barrel deterioration and infiltration.

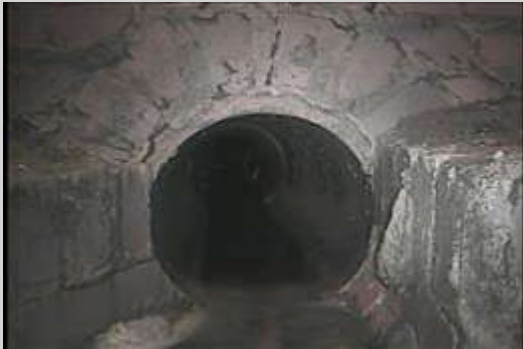
10 in. Circular Gravity Sewer Pipe Out @ 12 O'Clock

Deposits: ☐ None ☒ **Mud** ☐ Sludge ☐ **Debris** ☐ Grease

Infiltration: **Evidence** Pipe Seal Cond: **Unknown**

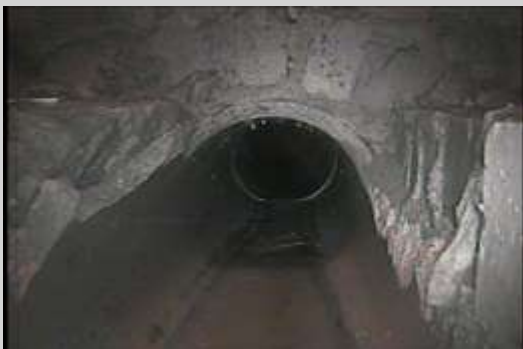
6 in. Circular Gravity Sewer Pipe In @ 3 O'Clock

Infiltration: **Evidence** Pipe Seal Cond: **Unknown**

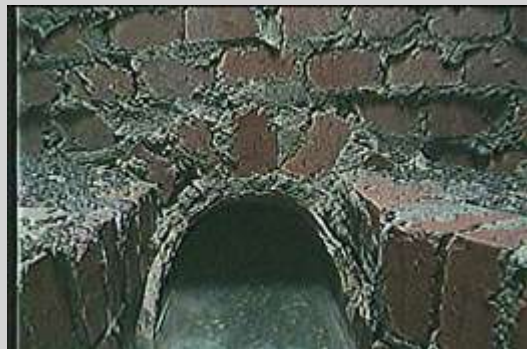
Pipe In @ 9 O'Clock

Barrel deterioration and infiltration. Channel deterioration.

Deposits: ☐ None ☐ Mud ☐ Sludge ☒ **Debris** ☐ Grease

Pipe Seal Cond: **Cracked**
